DEVELOPMENT OF INSTRUMENTATION TO MONI-  
TOR RADIAL DEFORMATION OF THE MEDIUM  
AROUND AN UNDERGROUND OPENING

Battelle Memorial Institute

# Development of Instrumentation to Monitor the Radial Deformation of the Medium Around an Underground Opening

Semiannual Technical Report  
September 29, 1972

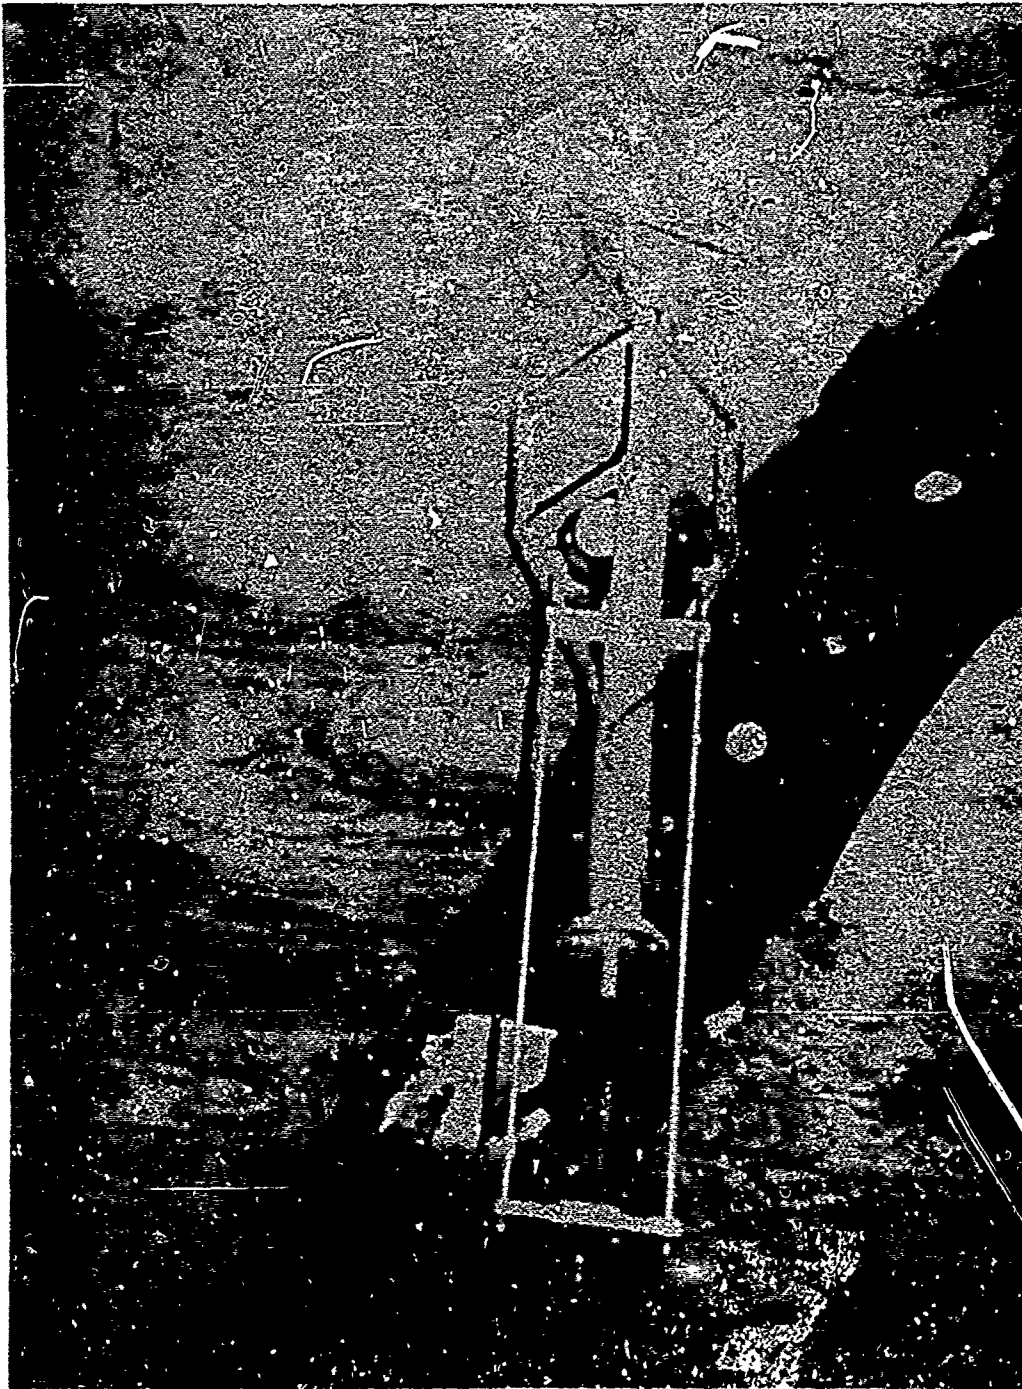
FIGURE 19. Anchor Pull Test Stand Being Used to Pull the Anchors  
After the Third Test

The shallow anchor pulled loose with a 500 lb pull.

The deep anchor held solid with a 2000 lb pull.
